## Fire Investigator Dies After Being Struck by a Chimney That Collapsed During an Origin and Cause Fire Investigation - New York

## Investigative Report #99F-06

### Fire Investigator Dies After Being Struck by a Chimney That Collapsed During an Origin and Cause Fire Investigation - New York

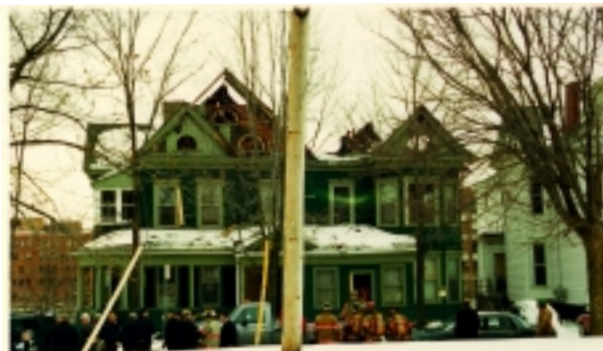
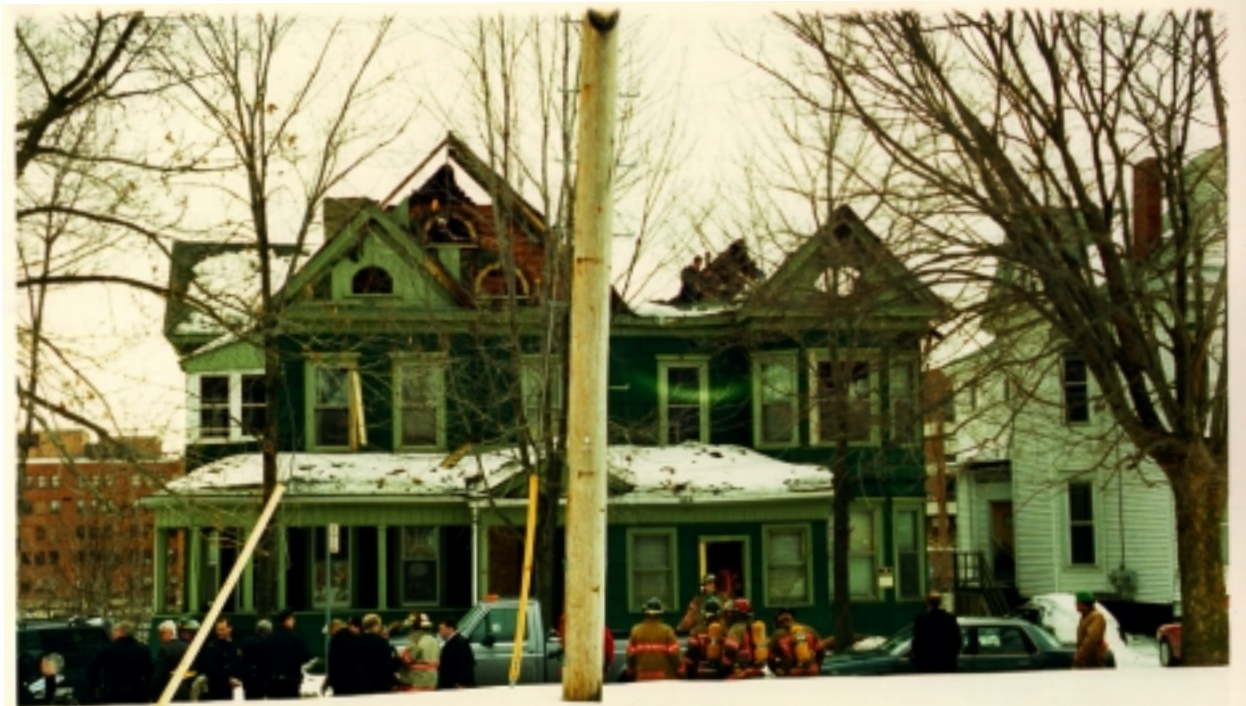
Figure 1. Fire Scene

On January 14, 1999, a fire at a residence more than 80 years old and containing three apartments

was reported to the city fire department (see Figure 1). The fire department responded and extinguished the fire within 1 hour by performing an exterior attack with deck guns. After salvage operations were completed the fire companies returned to their departments. It was determined that the investigation to determine the fire's origin and cause would be delayed until weather conditions improved from the sub-zero temperatures of the day of the fire. Five days after the fire, weather conditions had improved and an origin-and-cause investigation was scheduled for January 19, 1999. About 1030 hours on the day of the incident, a fire investigator from the department met with an insurance adjuster, a private fire investigator and an electrical consultant at the fire scene to conduct the investigation. All four men proceeded to the attic area where the investigation commenced. About 10 minutes into the investigation, the insurance adjuster left the area and proceeded to the floors below to continue his investigation. The three other men, including the victim, remained in the attic and sifted through debris for clues to the origin of the fire. About 2 ½ hours later, they had moved to an area near a brick chimney that was free-standing about 13 feet above the floor level of the attic. The section of the free-standing chimney above the roof line appeared to have been an add-on to the original chimney, as two different types of brick were present from below and above the roof line to the top of the chimney. The chimney had been constructed of single bricks and mortar stacked together, and the chimney contained no internal liner/flue (see Figure 2.). The dimensions of the section of chimney which collapsed were 98 inches high by 38 inches wide by 17 inches deep, and its estimated weight was between 2,500 - 3,000 lbs. The chimney had been free-standing for 5 days and had been subjected to direct fire exposure, freezing and thawing

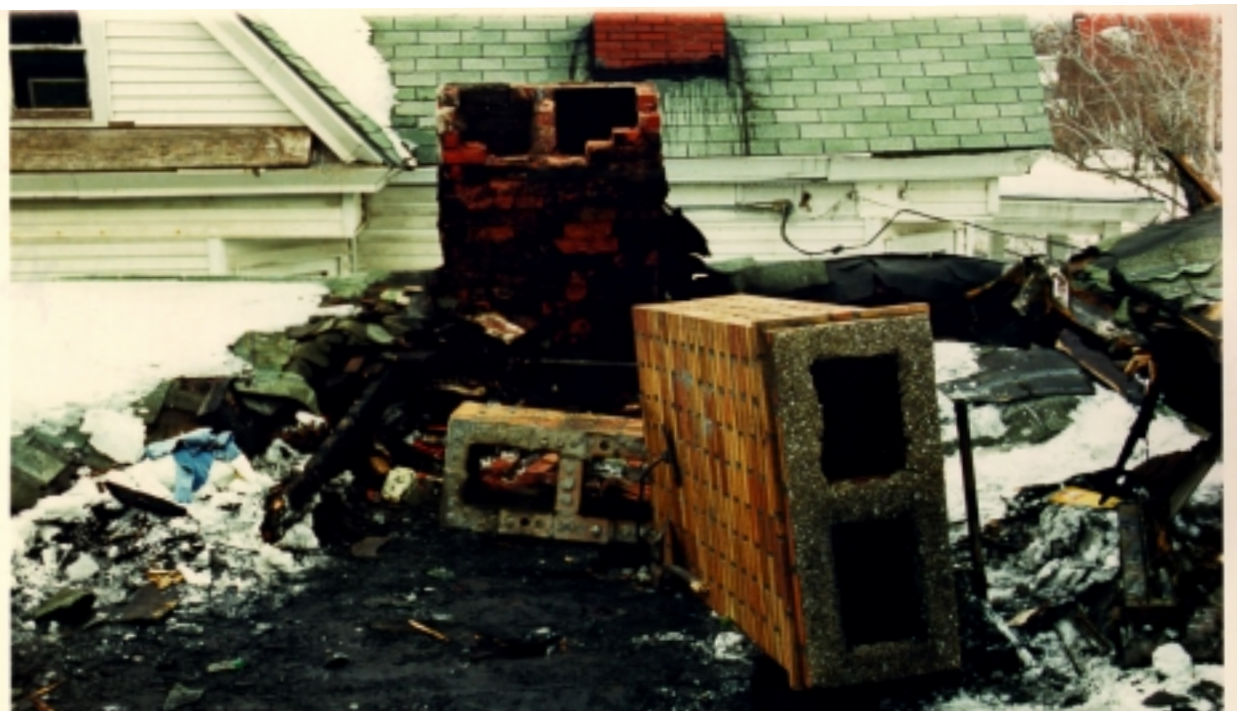
temperatures (-7° to 44° F), water loading from deck guns, and wind gusts to 56 m.p.h. *Note: About the time of the incident, wind was constant from the west and at a 90° angle to the chimney, between 33 - 36 m.p.h.*

After discussing the stability of the chimney the three men decided to continue work near it even though they had seen it swaying in the wind. Although working within 15 feet of one another, the three men were positioned at different locations in relation to the chimney. Two of the investigators were off to one side of the chimney, while the victim was located about 8 feet directly in line with the base of the chimney. The three men were sifting through and inspecting the debris when the chimney suddenly and silently collapsed and fell onto the victim. The sound of the chimney hitting the floor alerted the two other men, and after realizing what had occurred, they tried to lift the chimney off the victim, but it was too heavy. One of the men ran to a neighboring house and called 911. At this time another fire investigator arrived on the scene and was apprised of the situation. He used his fire radio to call for a rescue company. Hearing the call, two fire Chiefs arrived on the scene within a few minutes and the five men were able to lift the chimney off the victim. Emergency cardiopulmonary resuscitation was initiated and the victim was transported to the local hospital where he later died of his injuries.

Figure 2. Collapsed brick chimney

*Recommendation #1: Fire department personnel should conduct an assessment of the stability and safety of the structure, e.g., roofs, ceilings, partitions, load-bearing walls, floors, and chimneys, before entering damaged, e.g.,*

*by fire or water, structures for the purpose of investigations.*

Discussion: Due to the destructive powers of fire, most structures that have been involved in fires or explosions are structurally weakened. Analysis of the exterior of the structure should be done continuously while conducting exterior scene investigations. Similarly, before the interior examination is conducted, the structure should be determined safe to work in by conferring with the Incident Commander or requesting an inspection from building and safety. If necessary, the investigator should seek the help of qualified structural experts to assess the need for the removal of dangerously weakened construction or should make provisions for shoring up load-bearing walls, floors, ceilings, roofs, or as in this case, a chimney. In this case, had a thorough assessment been made of the structure, including the chimney, the origin-and-cause investigation could have been postponed until the area around the chimney had been roped off and a collapse zone established, or the chimney had been demolished or stabilized.<sup>1,2</sup>
